WIGHTLINK, PORTSMOUTH

Structural repairs and maintenance at Wightlink's Portsmouth Station Terminal

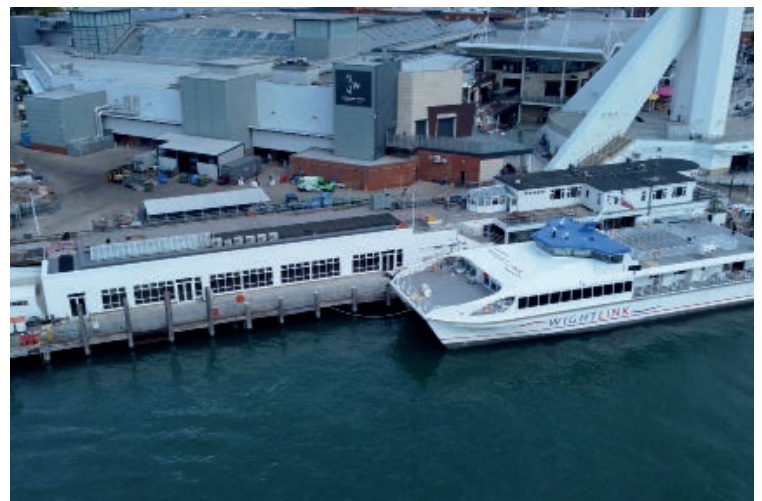
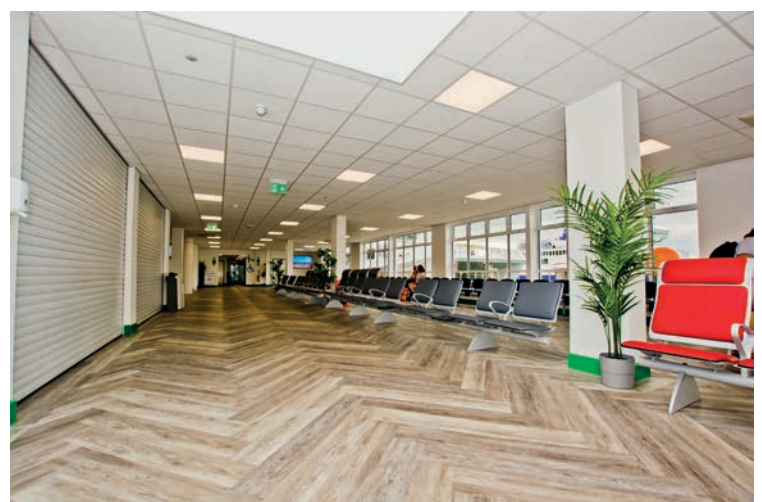
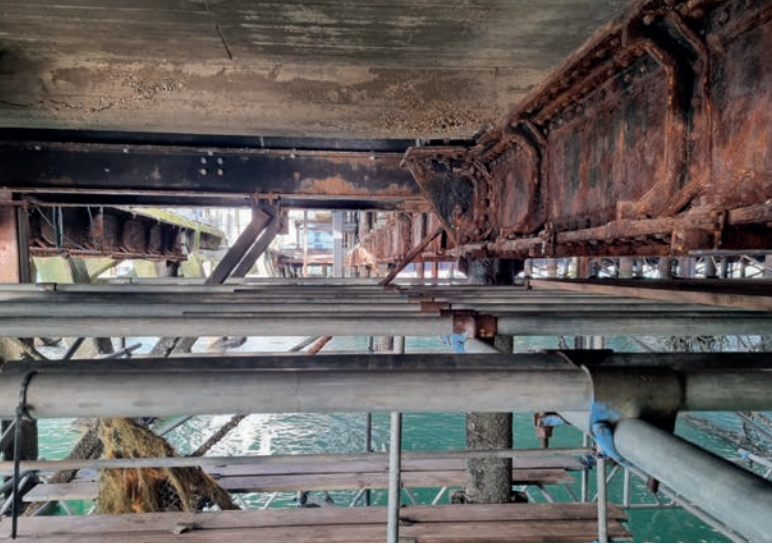
The main works comprised removal of corroded steel support beams to the ferry terminal and their replacement. We also undertook works to steel columns supporting the upper part of the terminal.

- A crash deck was installed below the concrete floor whilst we cut the existing concrete floor into sections to allow it to be removed from the steel support beams, removed from site by barge
- Cut out and take off site steel beams supporting the concrete floor
- Repair existing column heads
- Supply and fit replacement main steel beams. Beam ends were measured and fabricated so bearings to pile caps did not require shims to support or level them
- Supply and fit replacement steel cross beams

Columns supporting the roof and concrete casings to the base of the existing columns were carefully cut, broken out and removed to a height of 1m. New replacement column bases were measured and secured in place. Whilst undertaking these repairs, the removal of the existing roof and installation of a new roof was instructed and undertaken as part of our main works.

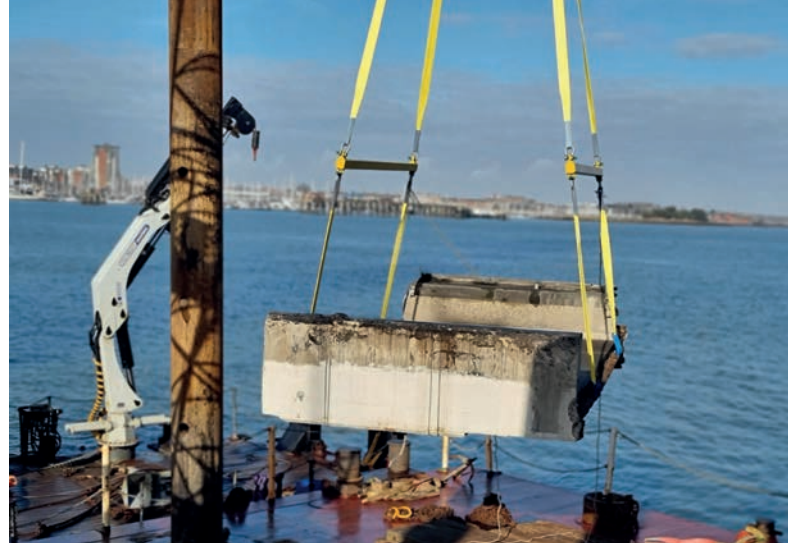
Once steelwork repairs were complete, we installed pre-fabricated concrete floor planks and set them in place over the steelwork. The new roof structure was installed once the structural integrity of the new floor structure was complete with a single ply membrane roof system.

The external walls were of SFS construction, externally faced with Euroform Versaliner Sheathing and 8mm Trespa. The “set aside doors and windows” were reinstalled in the new openings, as were the internal doors, partitions, sliding doors and fire shutters.
